# **Mobile Pentium® II Processor Specification Update**

Release Date: September 1998

Order Number: 243887-002

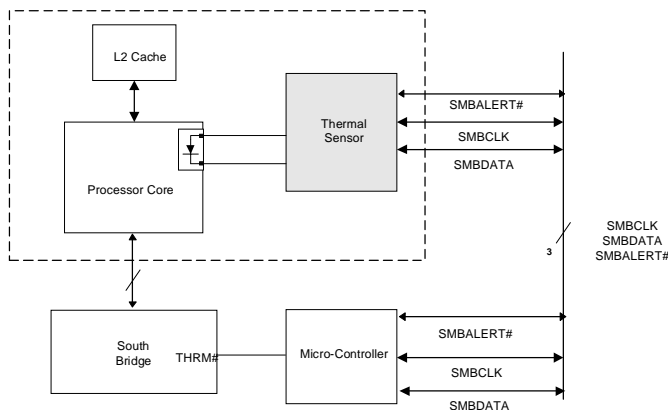
**Figure 1. An Example of Micro-controller Driven Thermal Management**

**PROBLEM:** The Mobile Pentium II processor and the Pentium II processor Mobile Module have a thermal sensor that monitors the processor core's temperature. Please note that desktop systems could have a similar thermal device. The thermal sensor asserts SMBALERT# if the processor temperature exceeds the temperature limits set in the Alarm Threshold Registers ( $T_{HIGH}$ ,  $T_{LOW}$ ). It also sets the corresponding Status Register bits to identify the cause of the interrupt. Figure 1 gives one example of the how the SMBALERT# signal could be used in a system.

Under the conditions described below, the thermal sensor incorrectly generates the SMBALERT# interrupt. All of the following conditions must be met to trigger a false interrupt:
